U.S.-Canada Power System Outage Task Force

Final Report on the August 14, 2003 Blackout in the United States and Canada: Causes and Recommendations

April 2004

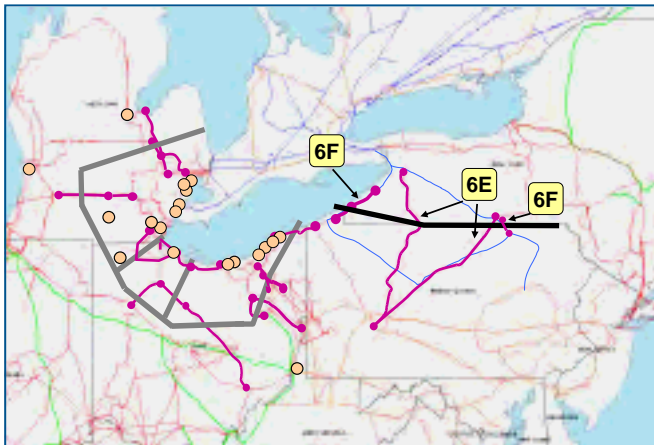
Responding to the swing of power out of Michigan toward Ontario and into New York and PJM, zone 1 relays on the 345-kV lines separated Pennsylvania from New York (Figure 6.20). Homer City-Watercure (177 miles or 285 km) and Homer City-Stolle Road (207 miles or 333 km) are very long lines and so have high impedance. Zone 1 relays do not have timers, and operate instantly when a power swing enters the relay target circle. For normal length lines, zone 1 relays have small target circles because the relay is measuring a less than the full length of the line—but for a long line the large line impedance enlarges the relay’s target circle and makes it more likely to be hit by the power swing. The Homer City-Watercure and Homer City-Stolle Road lines do not have zone 3 relays.

Given the length and impedance of these lines, it was highly likely that they would trip and separate early in the face of such large power swings. Most of the other interfaces between regions are on short ties—for instance, the ties between New York and Ontario and Ontario to Michigan are only about 2 miles (3.2 km) long, so they are electrically very short and thus have much lower impedance and trip less easily than these long lines. A zone 1 relay target for a short line covers a

Figure 6.20. Western Pennsylvania Separates from New York, 16:10:39 EDT to 16:10:44 EDT

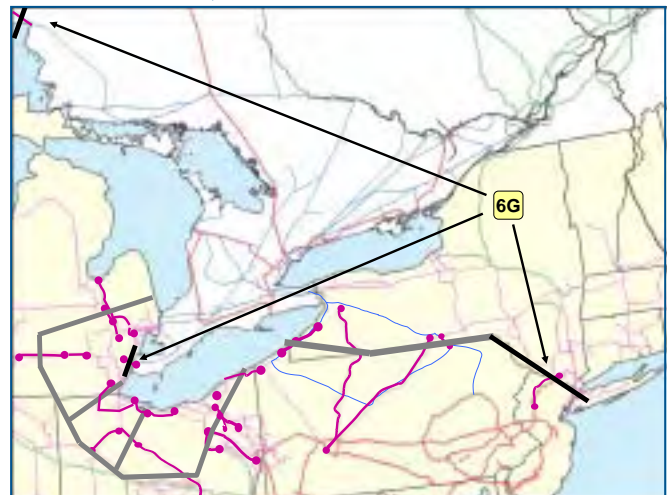
At 16:10:43 EDT, eastern Michigan was still connected to Ontario, but the Keith-Waterman 230-kV line that forms part of that interface disconnected due to apparent impedance (Figure 6.21). This put more power onto the remaining interface between Ontario and Michigan, but

Figure 6.21. Northeast Separates from Eastern Interconnection, 16:10:45 EDT

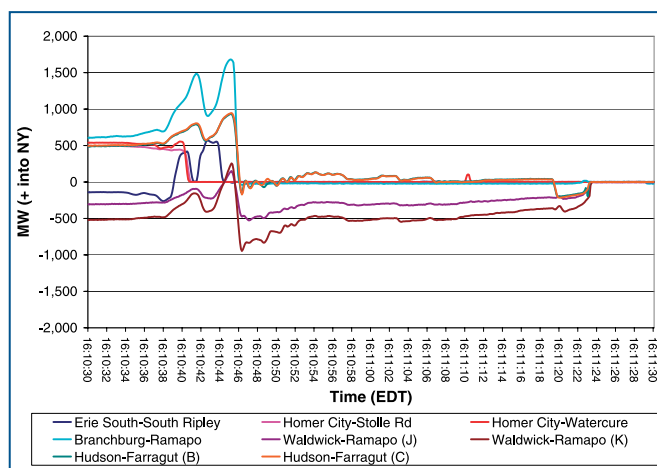
The 69-mile (111 km) long Branchburg-Ramapo 500-kV line and Ramapo transformer between New Jersey and New York was the last major transmission path remaining between the Eastern Interconnection and the area ultimately affected by the blackout. Figure 6.22 shows how that line disconnected at 16:10:45 EDT, along with other underlying 230 and 138-kV lines in northeast New Jersey. Branchburg-Ramapo was carrying over 3,000 MVA and 4,500 amps with voltage at 79% before it tripped, either on a high-speed swing into zone 1 or on a direct transfer trip. The investigation team is still examining why the higher impedance 230-kV overhead lines tripped while the underground Hudson-Farragut 230-kV cables did not; the available data suggest that the notably lower impedance of underground cables made these less vulnerable to the electrical strain placed on the system.

Figure 6.22. PJM to New York Interties Disconnect

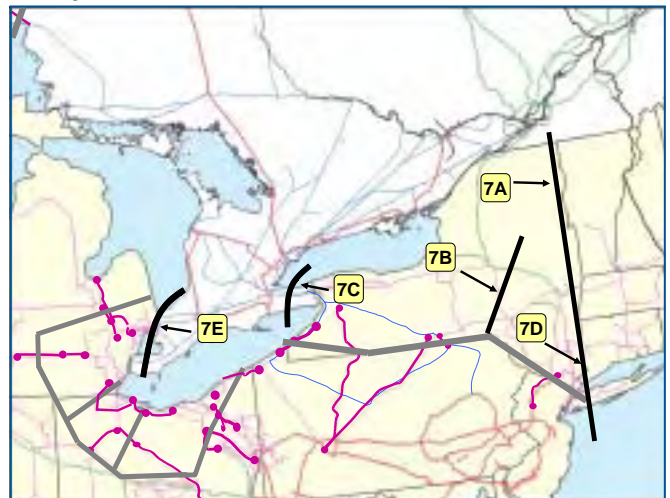
During the next 3 seconds, the islanded northern section of the Eastern Interconnection broke apart internally. Figure 6.23 illustrates the events of this phase.

Figure 6.23. New York and New England Separate, Multiple Islands Form

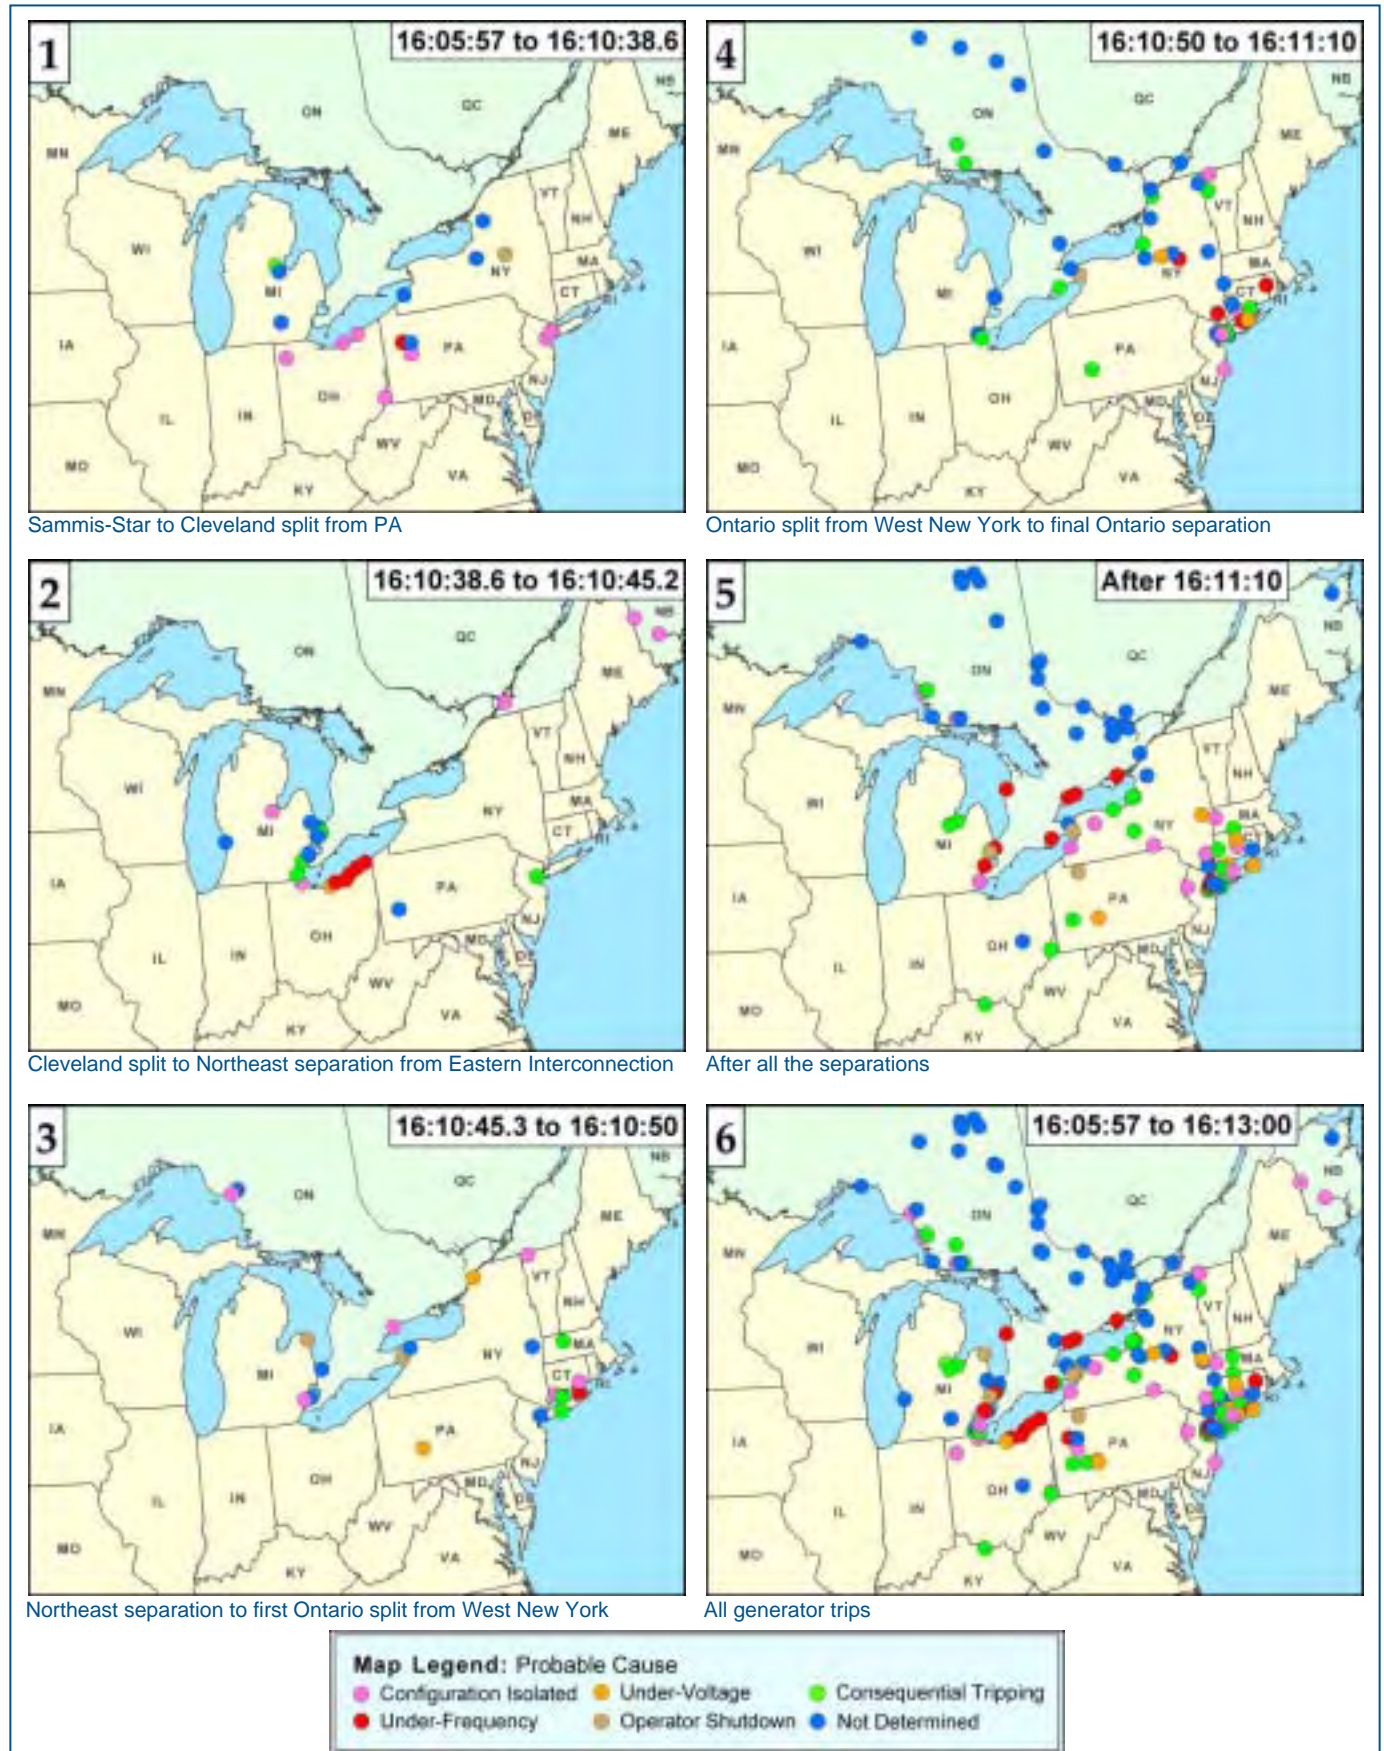
Within the overall cascade sequence, 29 (6%) generators tripped between the start of the cascade at 16:05:57 (the Sammis-Star trip) and the split between Ohio and Pennsylvania at 16:10:38.6 EDT (Erie West-Ashtabula-Perry), which triggered the first big power swing. These trips were caused by the generators' protective relays responding to overloaded transmission lines, so many of these trips were reported as under-voltage or over-current. The next interval in the cascade was as the portions of the grid lost synchronism, from 16:10:38.6 until 16:10:45.2 EDT, when Michigan-New York-Ontario-New England separated from the rest of the Eastern Interconnection. Fifty more generators (10%) tripped as the islands formed, particularly due to changes in configuration, loss of synchronism, excitation system failures, with some under-frequency and under-voltage. In the third phase of generator losses, 431 generators (84%) tripped after the islands formed,

many at the same time that under-frequency load-shedding was occurring. This is illustrated in Figure 6.24. It is worth noting, however, that many generators did not trip instantly after the trigger condition that led to the trip—rather, many relay protective devices operate on time delays of milliseconds to seconds in duration, so that a generator that reported tripping at 16:10:43 on under-voltage or “generator protection” might have experienced the trigger for that condition several seconds earlier.

Figure 6.24. Generator Trips by Time and Cause

protect its windings and coils from over-heating. Several of the other generators which tripped early in the cascade came off under similar circumstances as excitation systems were overstressed to hold voltages up. Seventeen generators reported tripping for over-excitation. Units that trip for a cause related to frequency should be evaluated to determine how the unit frequency triggers coordinate with the region's under-frequency load-shedding scheme, to assure that the generator trips are sequenced to follow rather than precede load-shedding. After UFLS operates to drop a large block of load, frequency continues to decline for several cycles before rebounding, so it is necessary to design an adequate time delay into generators' frequency-related protections to keep it on-line long enough to help rebalance against the remaining load.

Fourteen generators reported tripping for under-excitation (also known as loss of field), which protects the generator from exciter component failures. This protection scheme can operate on stable as well as transient power swings, so should be examined to determine whether the protection settings are appropriate. Eighteen units—primarily combustion turbines—reported over-current as the reason for relay operation.

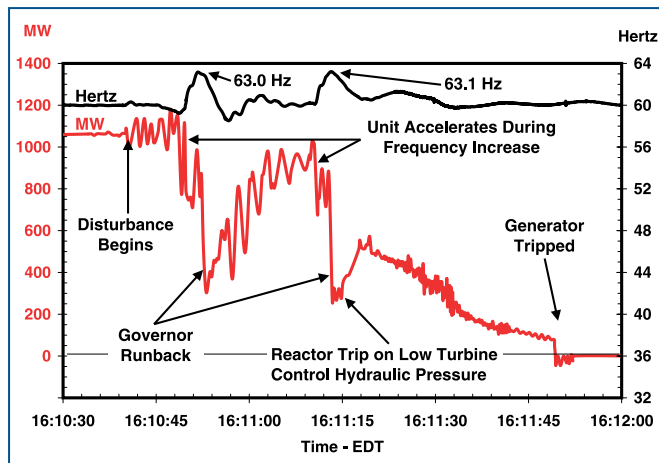
Figure 6.25. Events at One Large Generator During the Cascade

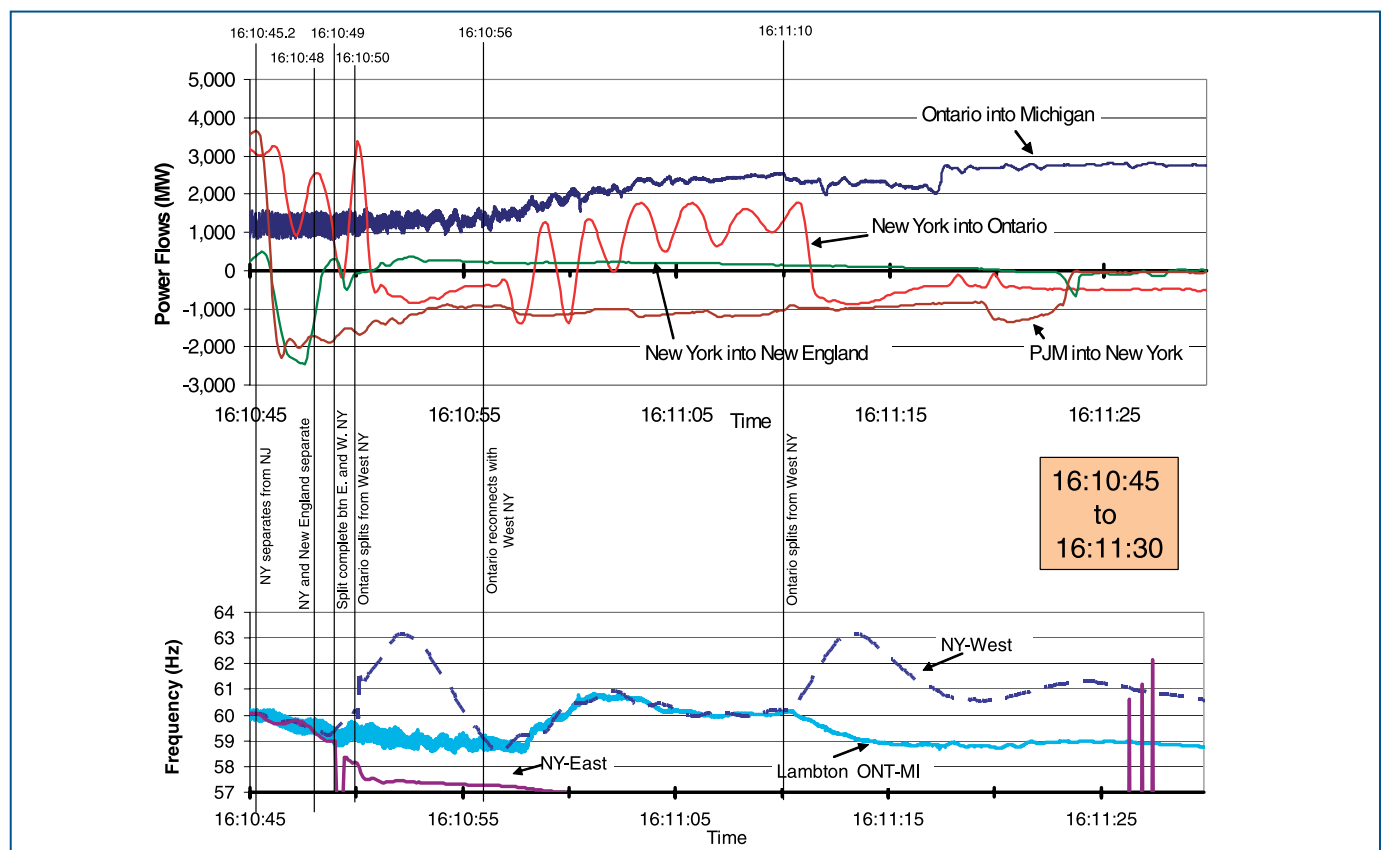
Figure 6.26 gives an overview of the power flows and frequencies in the period 16:10:45 EDT through 16:11:00 EDT, capturing most of the key events in Phase 7.

Figure 6.26. Measured Power Flows and Frequency Across Regional Interfaces, 16:10:45 to 16:11:30 EDT, with Key Events in the Cascade

Examination of the loads and generation in the Eastern New York island indicates before 16:10:00 EDT, the area had been importing electricity and had less generation on-line than load. At 16:10:50 EDT, seconds after the separation along the Total East interface, the eastern New York area had experienced significant load reductions due to under-frequency load-shedding—Consolidated Edison, which serves New York City and surrounding areas, dropped over 40% of its load on automatic UFLS. But at this time, the system was still experiencing dynamic conditions—as illustrated in Figure 6.26, frequency was falling, flows and voltages were oscillating, and power plants were tripping off-line.

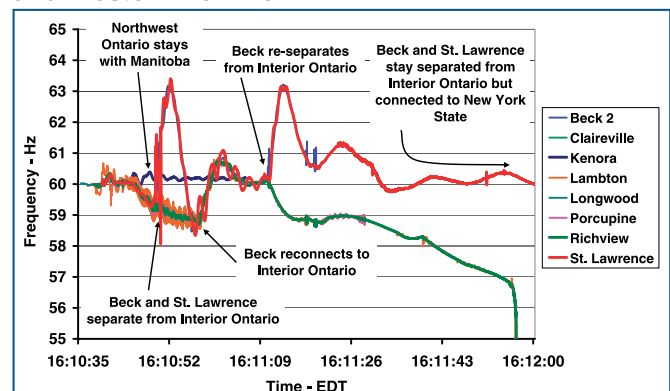
Figure 6.27. Frequency Separation Between Ontario and Western New York

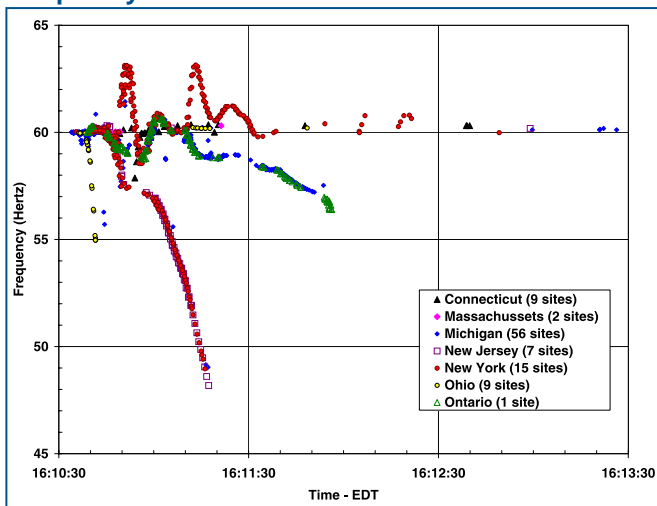
Figure 6.28 shows frequency data collected by the distribution-level monitors of Softswitching Technologies, Inc. (a commercial power quality company serving industrial customers) for the area affected by the blackout. The data reveal at least five separate electrical islands in the Northeast as the cascade progressed. The two paths of red diamonds on the frequency scale reflect the Albany area island (upper path) versus the New York City island, which declined and blacked out much earlier.

Figure 6.28. Electric Islands Reflected in Frequency Plot

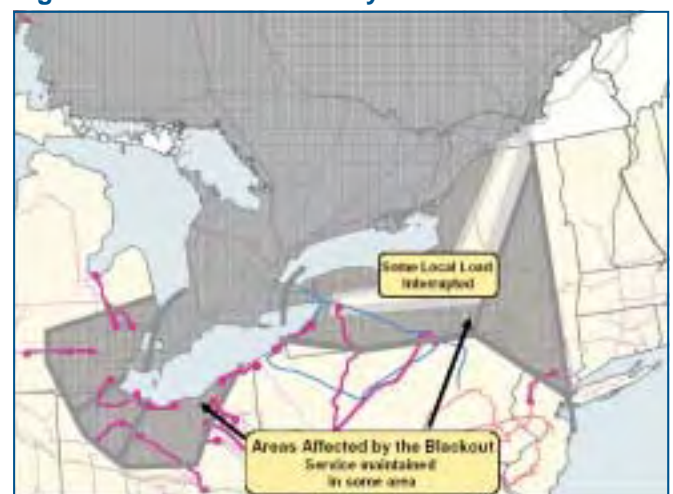
Most of the Northeast (the area shown in gray in Figure 6.29) was now blacked out. Some isolated areas of generation and load remained on-line for several minutes. Some of those areas in which a close generation-demand balance could be maintained remained operational.

Figure 6.29. Area Affected by the Blackout

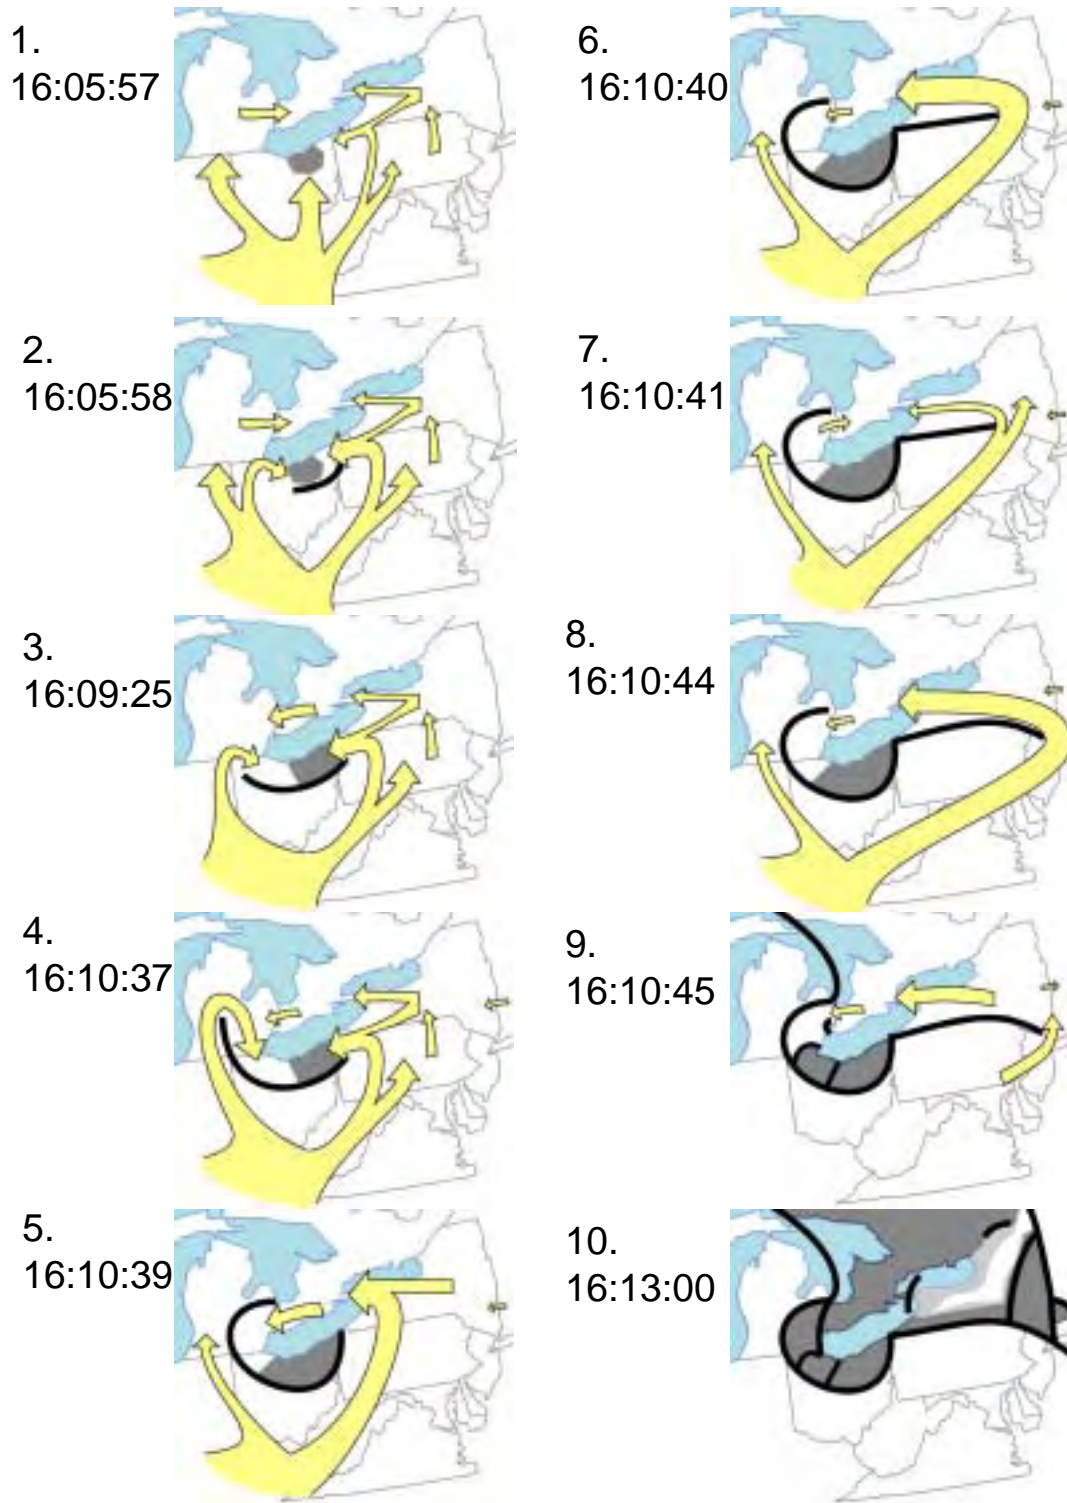
The entire cascade sequence is depicted graphically in Figure 6.30.

Figure 6.30. Cascade Sequence

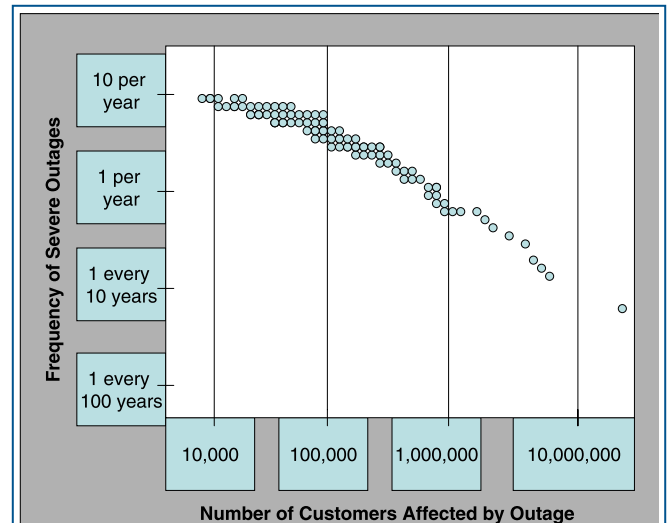
Short, localized outages occur on power systems fairly frequently. System-wide disturbances that affect many customers across a broad geographic area are rare, but they occur more frequently than a normal distribution of probabilities would predict. North American power system outages between 1984 and 1997 are shown in Figure 7.1 by the number of customers affected and the rate of occurrence. While some of these were widespread weather-related events, some were cascading events that, in retrospect, were preventable. Electric power systems are fairly robust and are capable of withstanding one or two contingency events, but they are fragile with respect to multiple contingency events unless the systems are readjusted between contingencies. With the shrinking margin in the current transmission system, it is likely to be more vulnerable to cascading outages than it was in the past, unless effective countermeasures are taken.

Figure 7.1. North American Power System Outages, 1984-1997
